A Bow Thruster has 4 Blades ...

*Ellhard Grefe
Chief engineer CMA CGM VERLAINE*

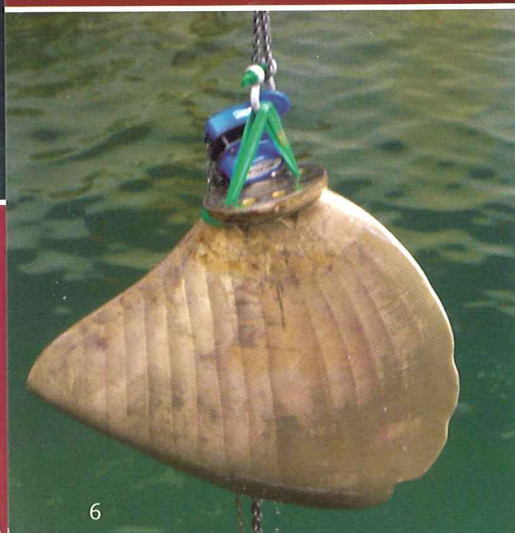
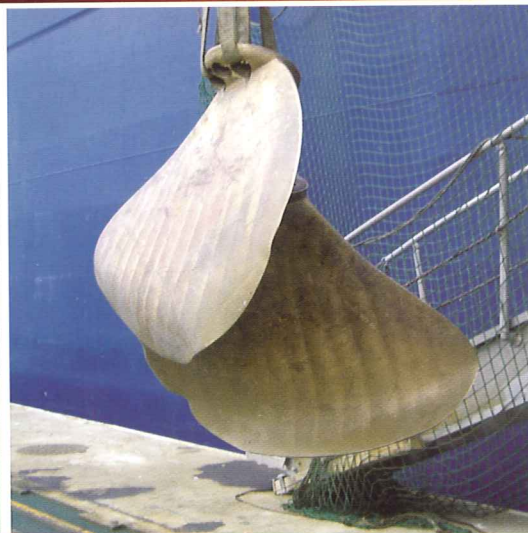
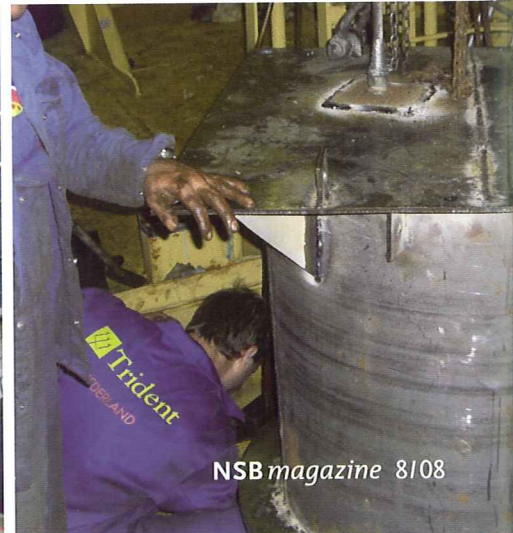
A start was made dismantling the bow thruster immediately after tying up in Le Havre. The remaining two propeller blades were removed under water and brought to land. At the same time, the preparations for dismantling the e-motor proceeded in the bow thruster room. Then in the pipe tunnel the side mountings had to be detached (very time-consuming) so that the gears could be exchanged in Rotterdam. Now it was also at last time to ask Adri, the head of the diver firm, how the gearbox was to be removed without us standing in the water. The solution was very simple: above on the flange of the electric motor a "bell" is installed which has an air connection, so that an air cushion is built up that presses the water level downwards. However, the "bell" first had to be welded together on the spot from individual parts, as it unfortunately did not fit in its entirety through the entry hatch. Moreover, in the bow thruster room an opening had to be made in the deck floor in order to set down the e-motor.

After this work had been done, the e-motor was finally hoisted away with chain hoists and the efforts of all and sundry and the "bell" constructed.

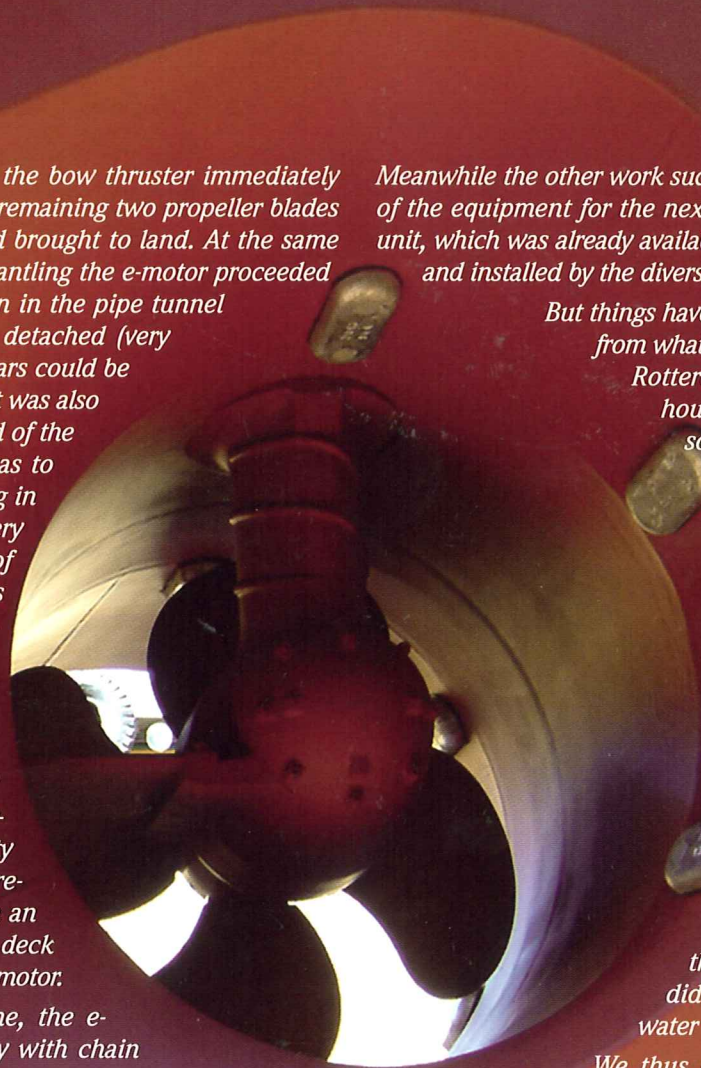
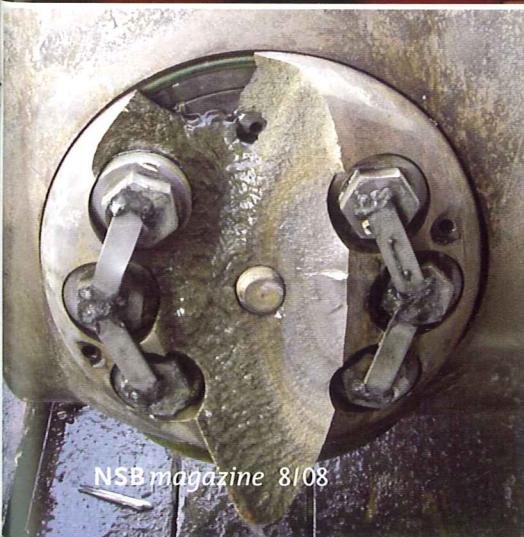
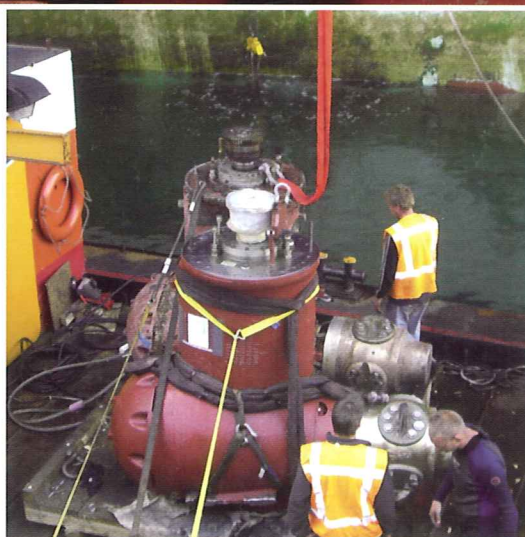
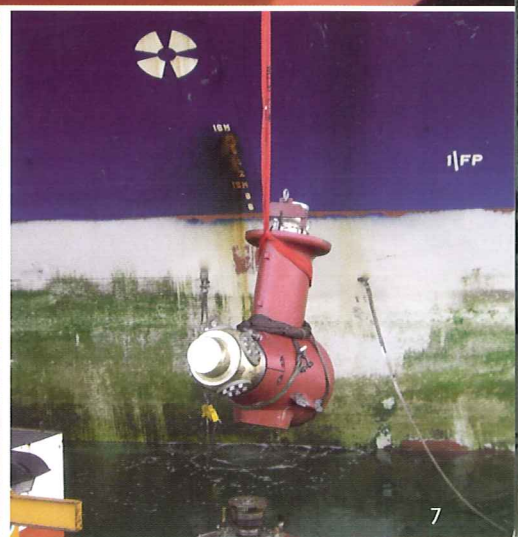
Two days later in Rotterdam came the big moment. Very early in the morning, the divers went down into the water and began with the dismantling work. Three hours later, the damaged bow thruster stood on the barge of the diving firm and became the object of our curiosity.

Meanwhile the other work such as bunkering and the taking on of the equipment for the next voyage went on. The new gear unit, which was already available, was then lifted into the water and installed by the divers. So far, so good!
